**PRELIMINARY INVESTIGATION OF THE
CHARACTERISTICS OF COASTAL LAKE OUTLETS
IN THE FLORIDA PANHANDLE**

Hurricane Opal Beach Recovery Study: Task C

**A. E. Browder
and
R. G. Dean**

**Florida Department of Environmental Protection
Bureau of Beaches & Coastal Systems**

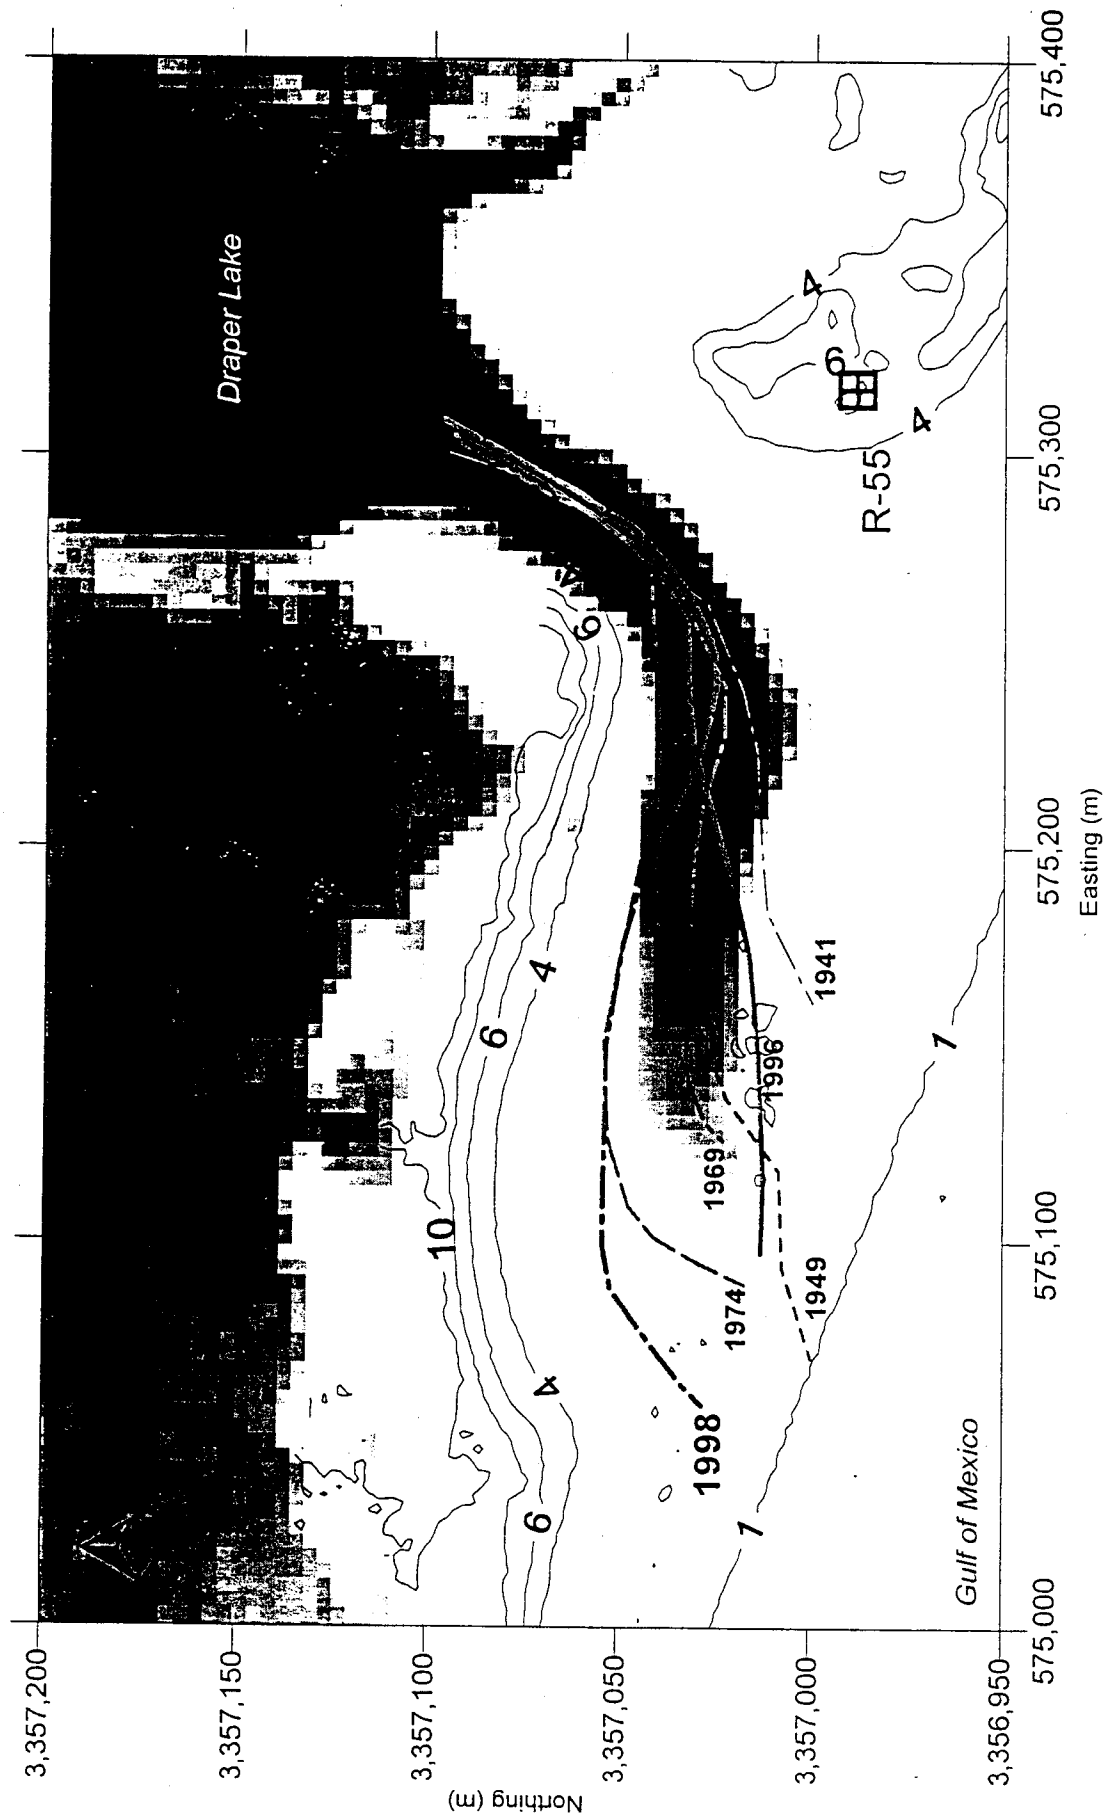
Table 1². At the time of the visit, conditions at several of the outlets were significantly different than in the October, 1996, laser survey dataset. Figure 4 illustrates the change in location of the thalweg of the outlet channel for Draper Lake, located near FDEP monument R-55 in Walton County. At the time of the laser survey, the thalweg was located closer to the center of the historic sweep area. By April, 1998, the channel had migrated westward approximately 150 ft and was encroaching upon the steep dune embankment and its sand fencing to the west. Several other sites were observed to be in a similar condition, such as Oyster Lake (Walton Co. R-46), Alligator Lake (Walton Co. R-69), and Eastern Lake (Walton Co. R-95). Many other sites were observed to be in a noticeably westward location (relative to previous aeriels), but were not in the vicinity of structures.

Figure 4 Variation in the location of the thalweg of the outlet channel for Draper lake in Walton County, FL. Contour elevations dated October, 1996, and are referenced to NGVD (1929). Photograph dated February, 1969.

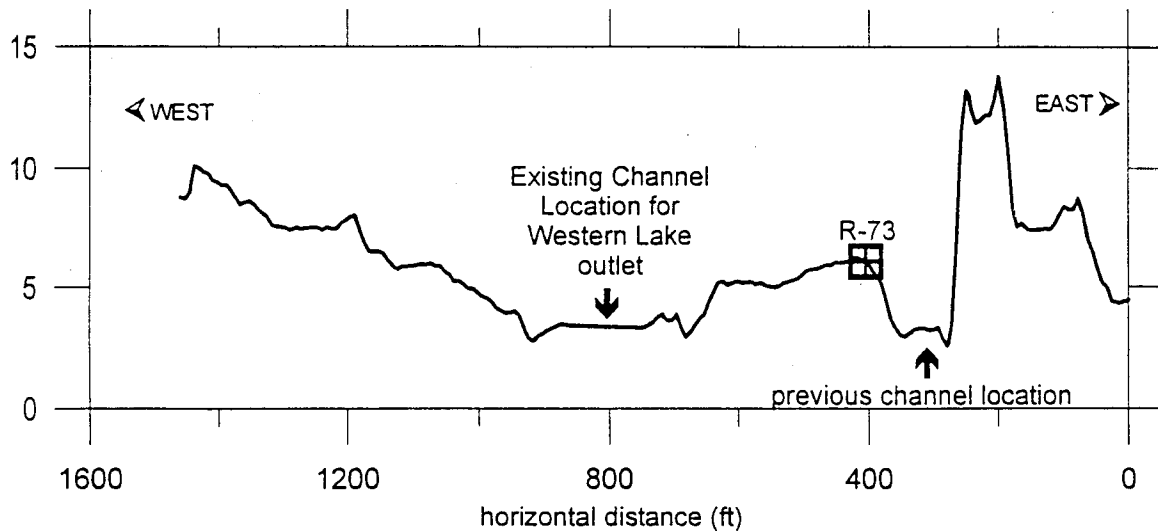
The overall low elevation of the sweep areas was quite noticeable. Overwash deposits, presumably from Hurricane Opal, were evident in many areas. Previous channel locations were also identified at many sites. Figure 5 presents an alongshore cross-section taken from the laser data for Western Lake at Grayton Beach State Park, looking onshore (elevation view). The cross-sectional profile indicates the present location of the channel, roughly 440 ft west of monument R-73, and a relict channel less than 100 ft to the east. The historic sweep path of this channel extends well beyond the longshore limits of this graph, covering a distance of 1,900 ft alongshore.

Figure 5 Alongshore elevation view of the channel outlet at Western Lake (Grayton Beach St. Park). The profile indicates the location of a relict channel.
